Orpheum Theatre acoustical renovation

AERCOUSTICS Engineering Limited — Toronto

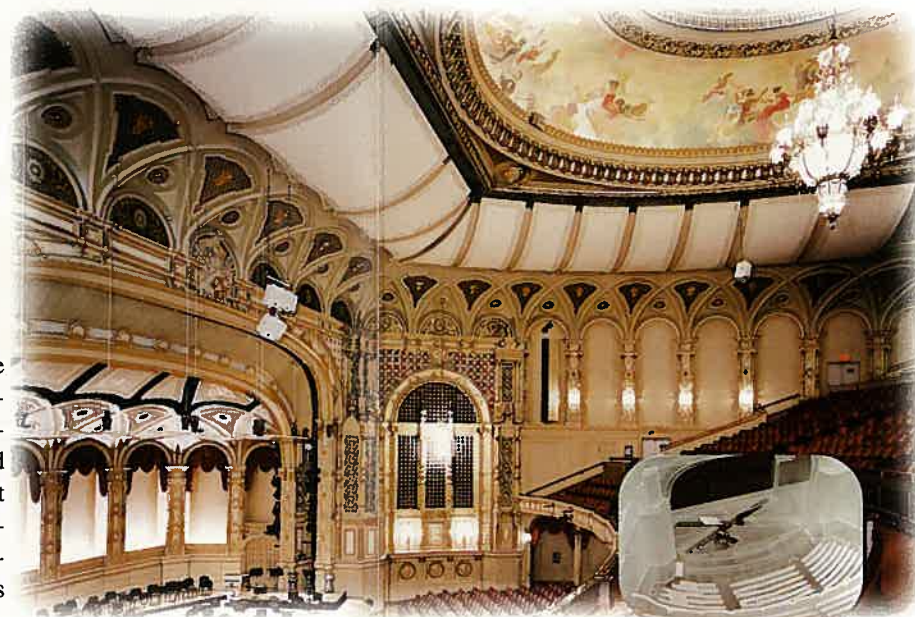
The impulse-response function con-

Inset: a view of the stage inside the 1:50 plexiglass model.

tains within it all the necessary information to describe the acoustics of the space. Under ideal conditions the impulse response of a concert hall should look like a

Christmas tree turned on its side. The focused reflection that led to the image shift dominates at 50 milliseconds. After the renovation, a measurement at the same location shows the complete eradication of the 50-ms focus and an ideal 'Christmas tree' shape.
